The Importance of Accurate Data in Outage Investigations Carried out by Wellington Electricity to Improve the Management of its Assets

Rebecca Harkerss – Graduate Engineer

18th August 2017

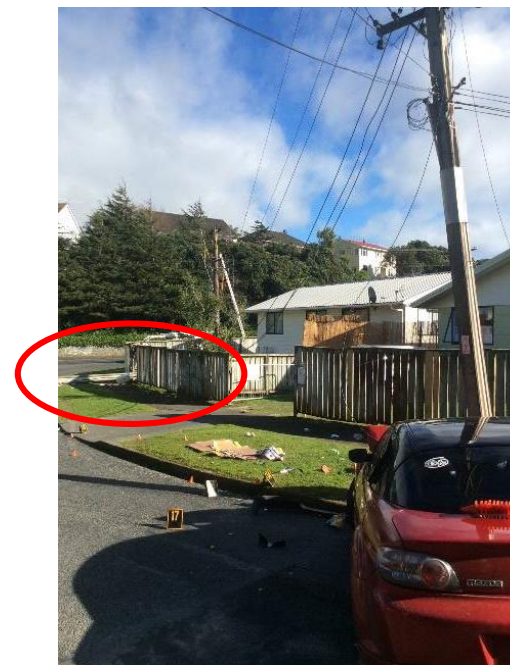
- **Date and Time:** 30/05/2017 9:30 a.m.
- **Feeder:** Porirua CB9
- **# Customers affected:** 1308
- **Cause:** 2 Cars vs Poles

- Investigate installing an air break switch (ABS) between the Hereford Street 'T-off' and the Champion Street substation.
- Redo LV link at Gloucester Street No 1 sub.

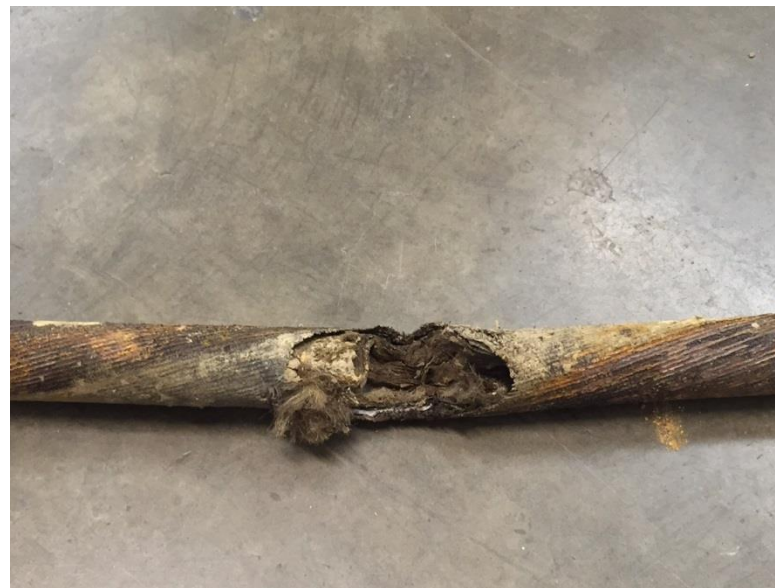
Example #2 – Waitangirua CB8 – 19th May 2017

- **Date and Time:** 19/05/2017 2:17 a.m.
- **Feeder:** Waitangirua CB8
- **# Customers affected:** 724
- **Cause:** Cable Fault

- Northpower will check Magnefix unit flags and reset them (where necessary) during the next annual inspection.
- Update standard for annual inspection to include checking and resetting flags.
