WEL Networks 33 kV Steel Pole Defects

Overhead Lines Forum

6 May 2021

Helen Gilbert - Beca

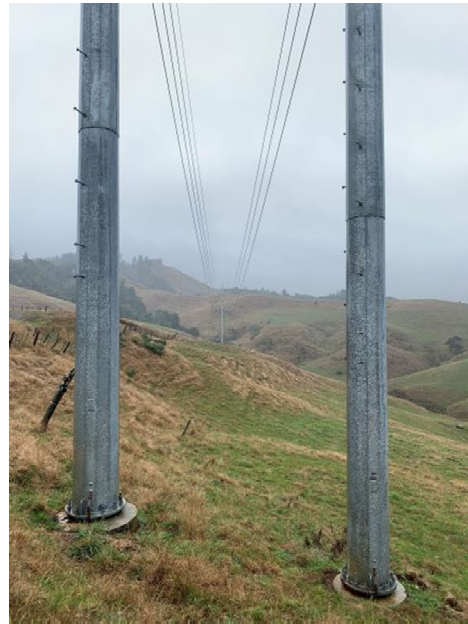
Foundation Holding Down Bolt Corrosion

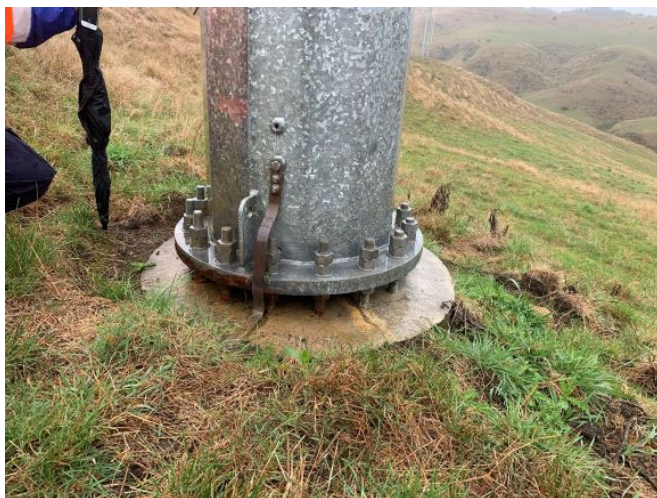
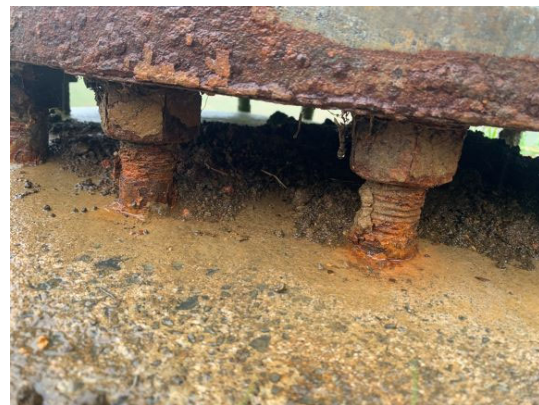
Foundation Holding Down Bolt Corrosion

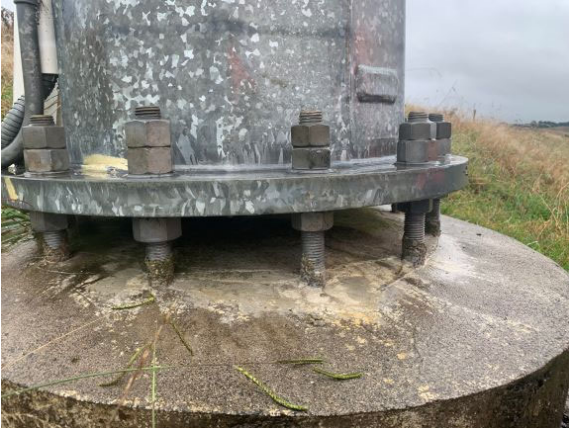
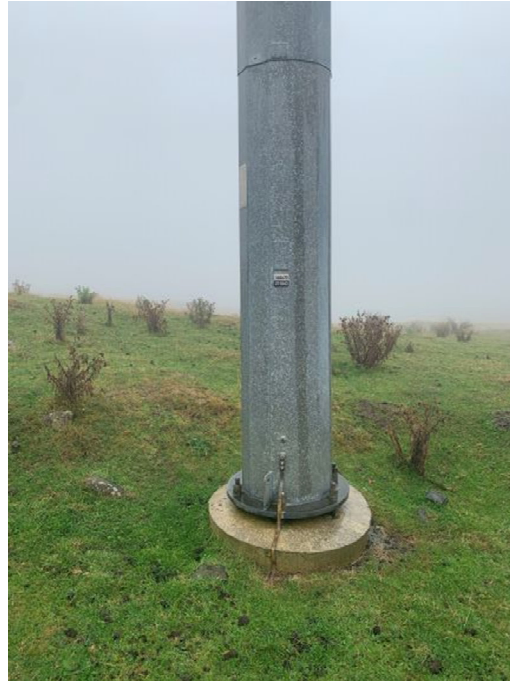
Foundation Holding Down Bolt Corrosion

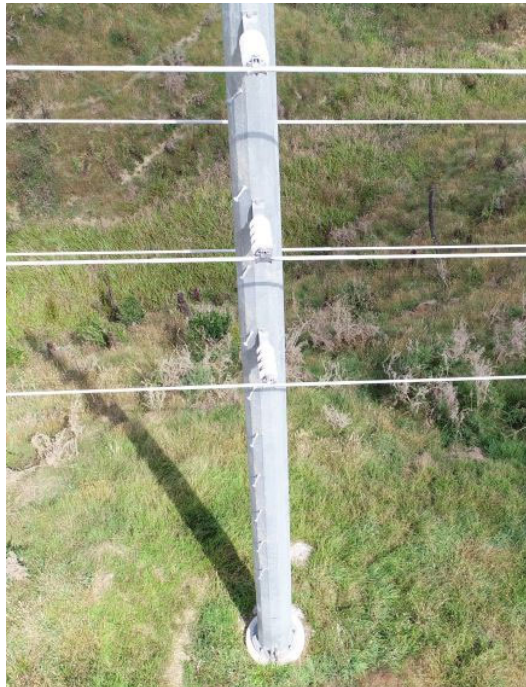
Blackened Horizontal Post Insulator Clamps

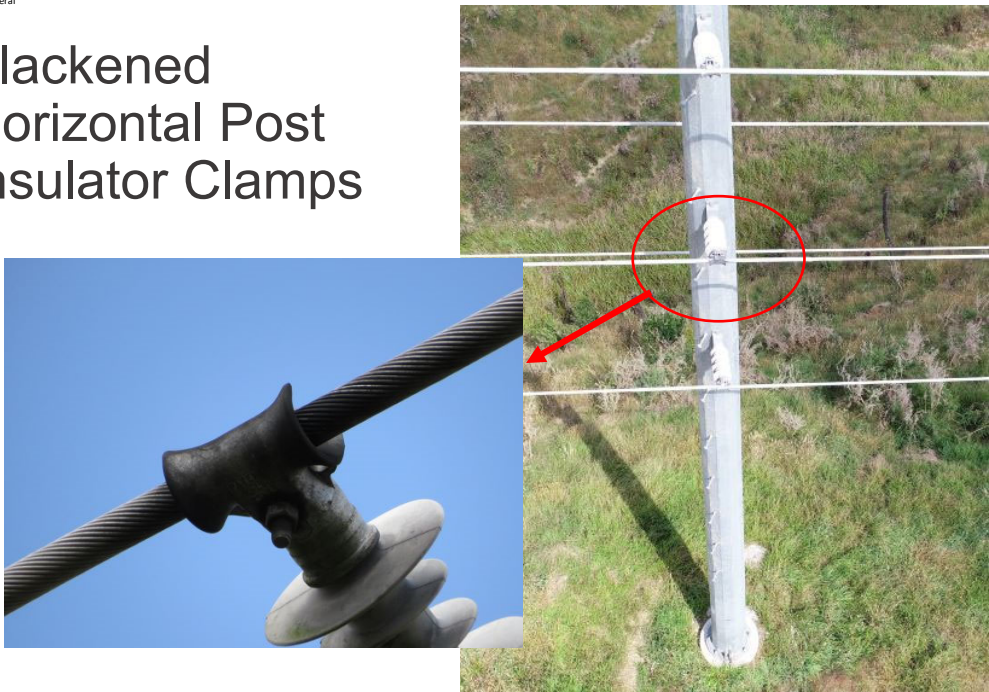
Blackened Horizontal Post Insulator Clamps

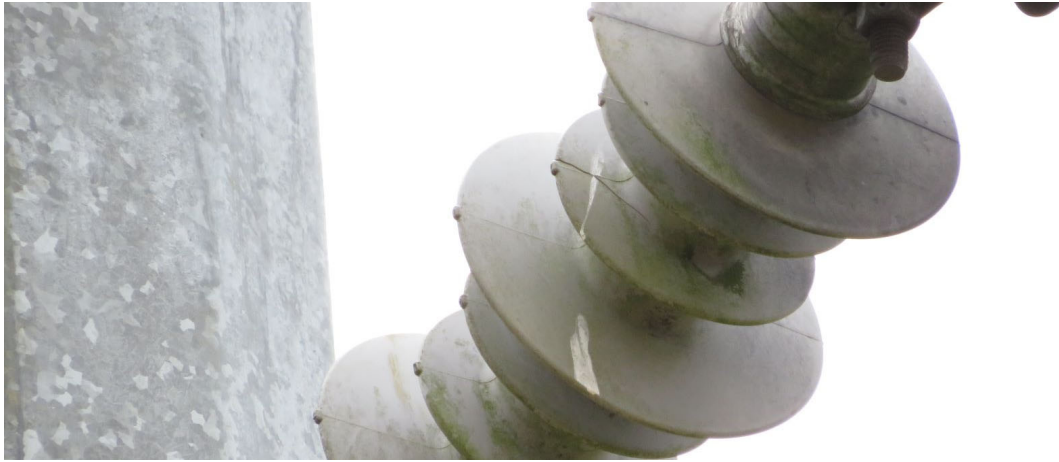
Biological Growth on Insulator

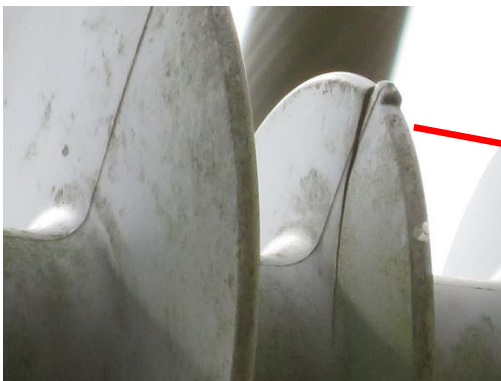
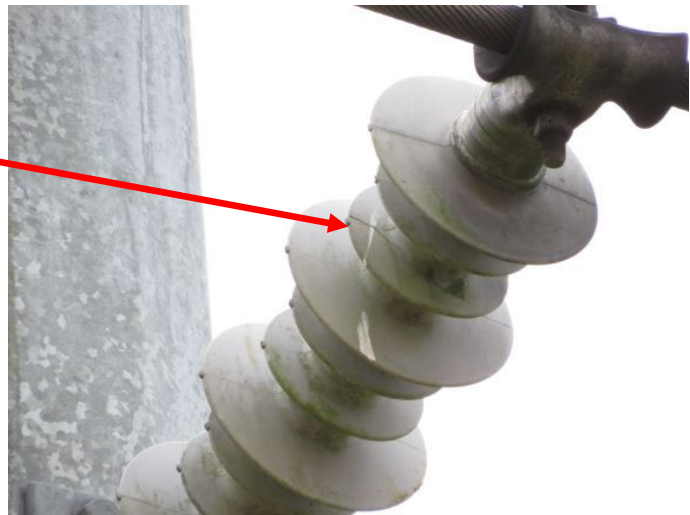
Biological Growth on Insulator

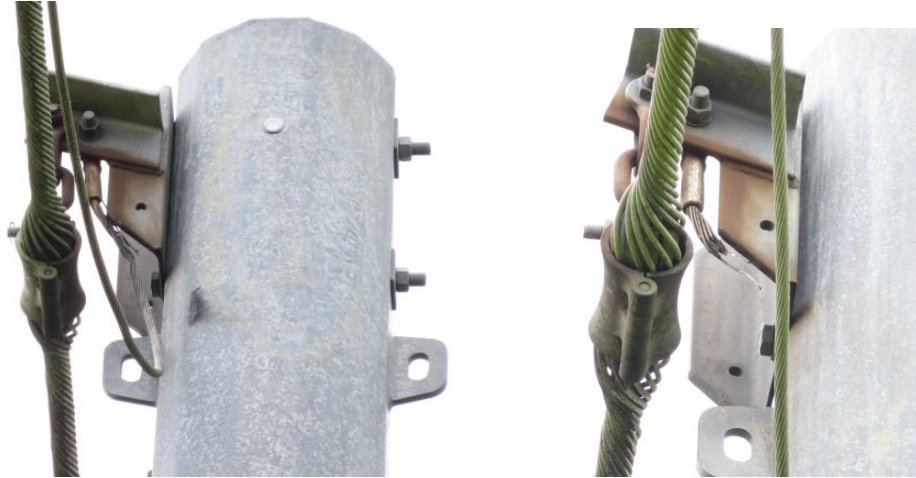
Earthbond Failure

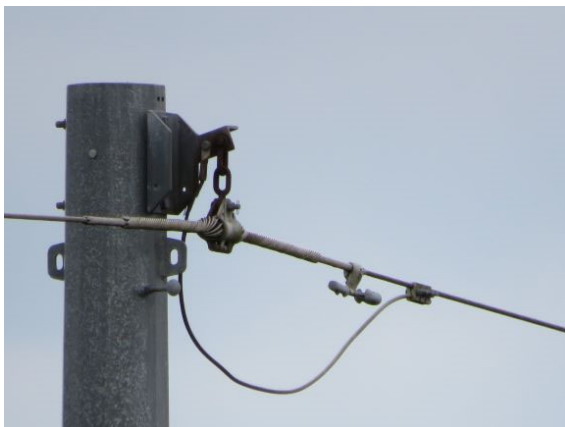
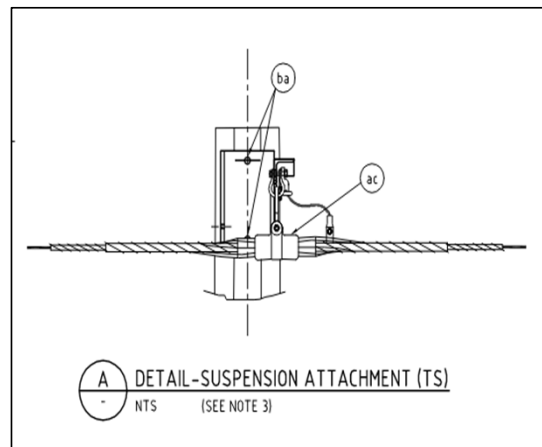
Earthbond Failure - Installed Earthbond vs. Design

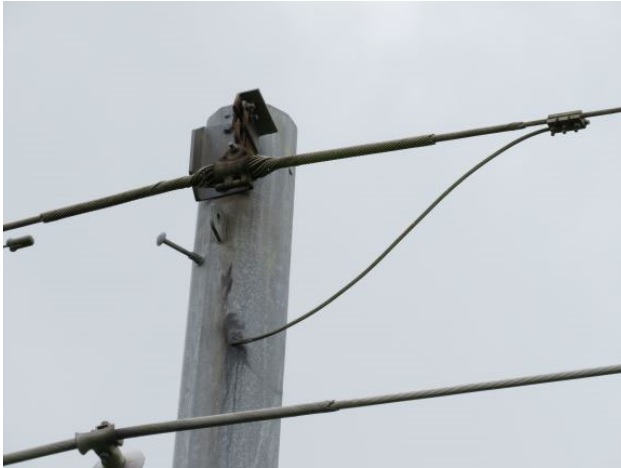
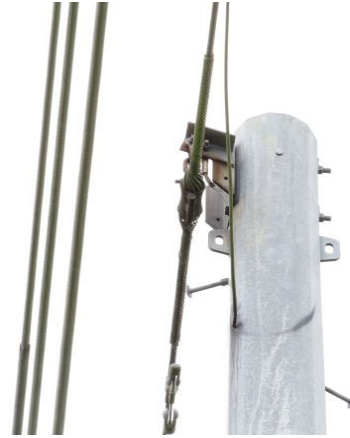
Earthbond Failure - Installed Earthbond vs. Design

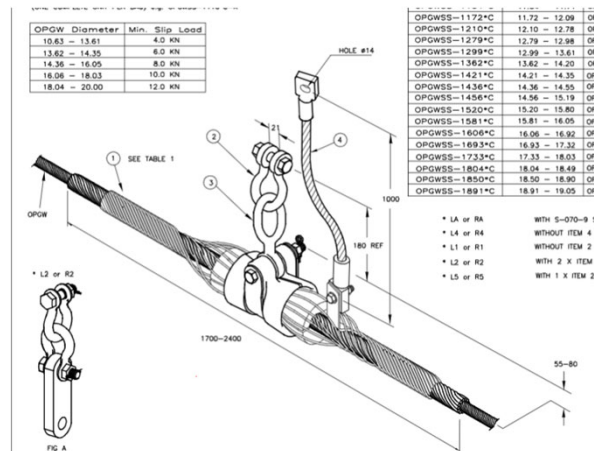
OPGW Clamp
Extract from
PLP Drawing 050-041-
RD

Earthbond Failure - Installed Earthbond vs. Design
