Safe by Design

SAFETY CONTACT Brazil 2014 Football World Cup Construction Fatalites

The following information from Iberdrola colleagues in Brazil relates to 8 fatalities sustained during the construction of 5 new stadiums in Brazil which along with 7 other existing venues will host the FIFA 2014 Football World Cup.

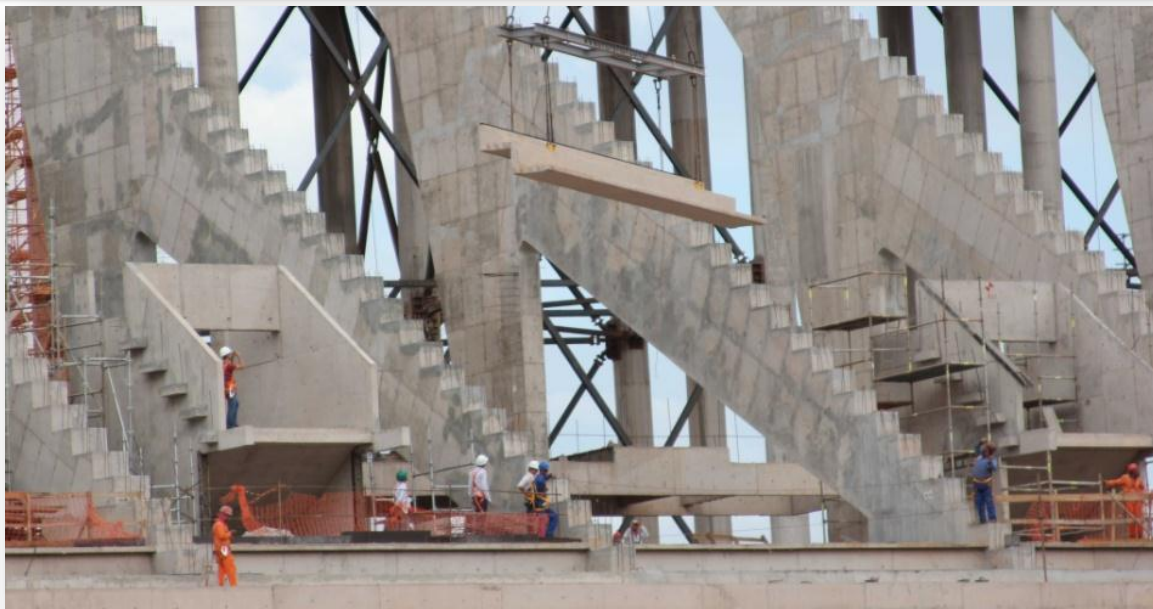
Garrincha Stadium(Brasilia).

A 21 year-old construction worker died after falling from a height of approximately 30m whilst working on the mounting of a concrete slab.

- The fact that a number of the accidents occurred with young workers (21 & 22 year-old) brings into question the experience, competency and training. The first fatality at Brasilia involved an apprentice carpenter .

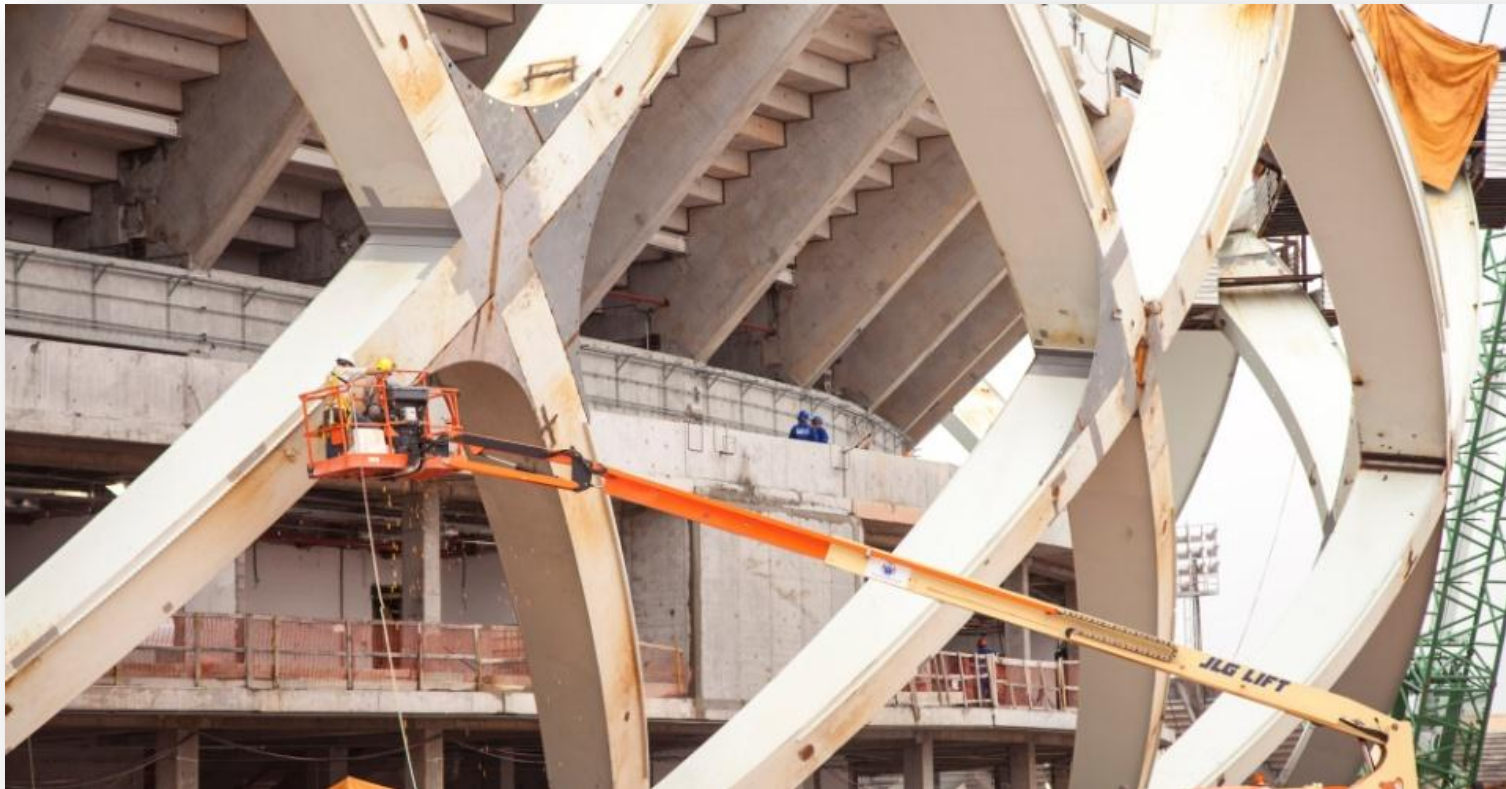
Amazonia Stadium(Manaus).

Construction worker Raimundo Nonato Lima Costa 49 years-old died after falling five metres, while attempting to climb between a concrete column and a scaffolding platform.

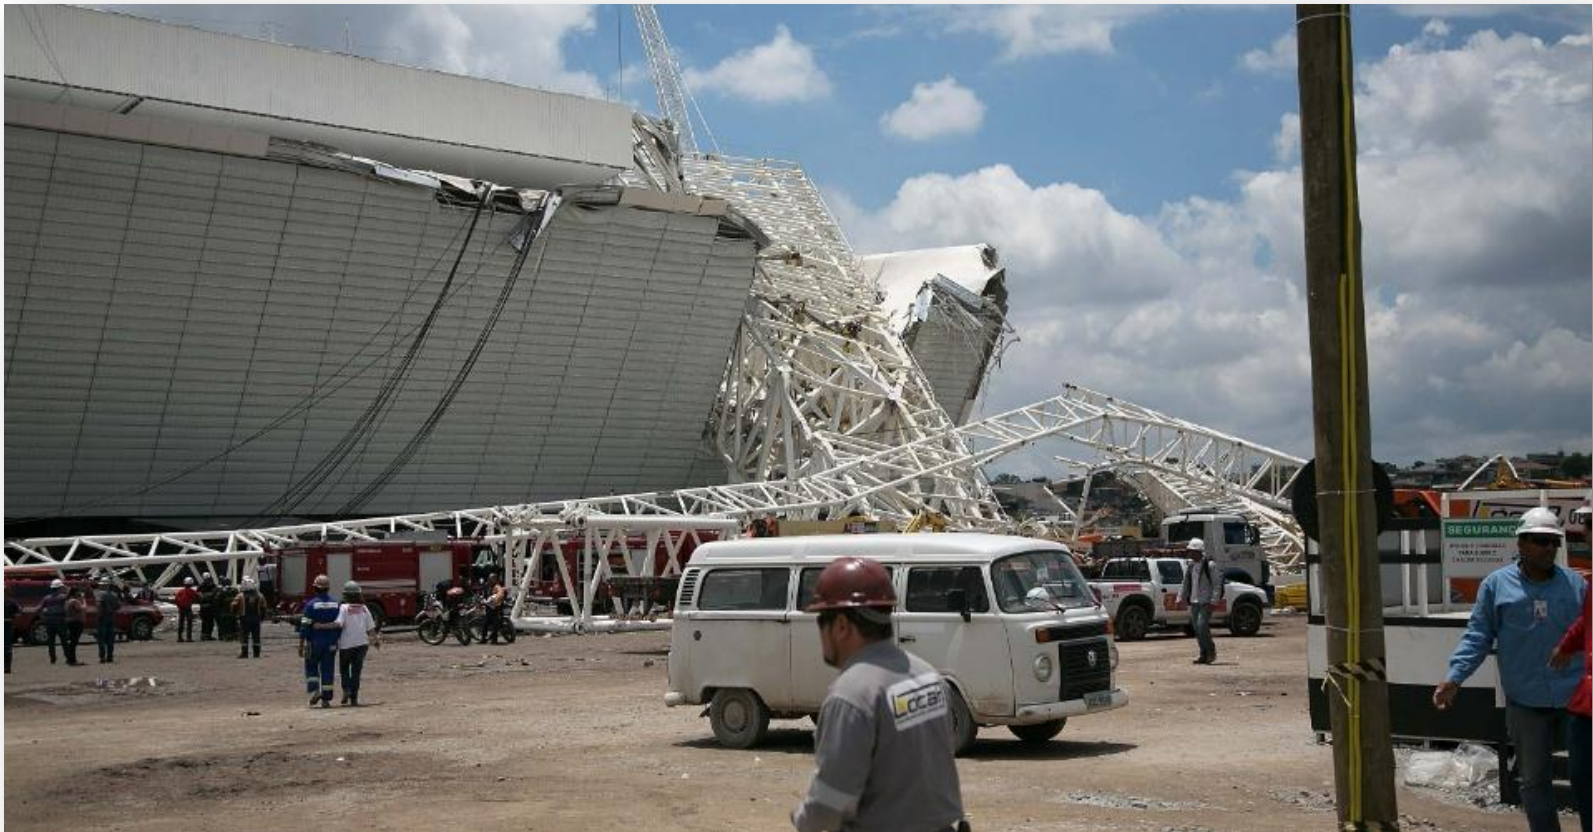
Itaquerao Stadium (São Paulo).

Two workers were killed when a crane collapsed while hoisting a 500-ton piece of roofing at the stadium that will host the World Cup opener in Sao Paulo.

- Work at a height of more than 2m, will be performed using a safety harness which shall be hooked onto a stable structure or on a line of life.
- In works that require the use of cranes, we must insure that the supports are fit for purpose and suitable for the application. In addition, ground surveys will be performed prior equipment being installed to ensure the land where the equipment positioned is highly stable, especially after strong rains or on sandy soils that show poor ground compaction.

- Overhead manoeuvres of heavy or large elements must be performed using approved procedures (lifting plans, method statements & risk assessments) to ensure all risks controls are fully applied.

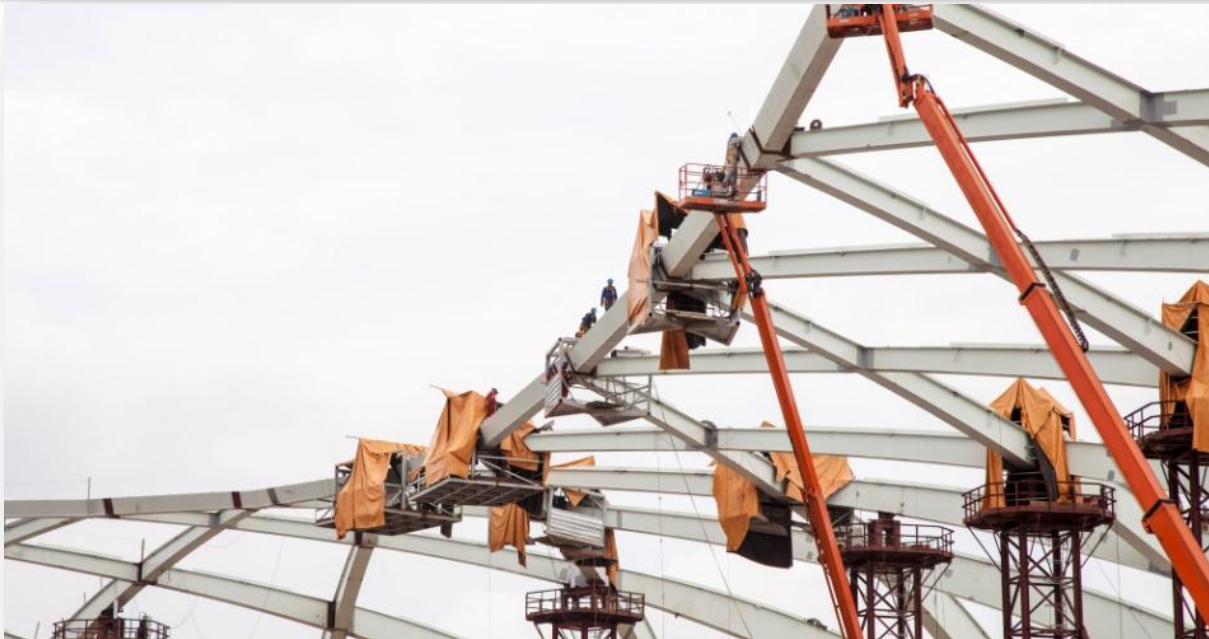
Amazonia Stadium (Manaus).

22-year-old Marcleudo de Melo Ferreira fell 40 metres when he was working on an overhead lighting installation.

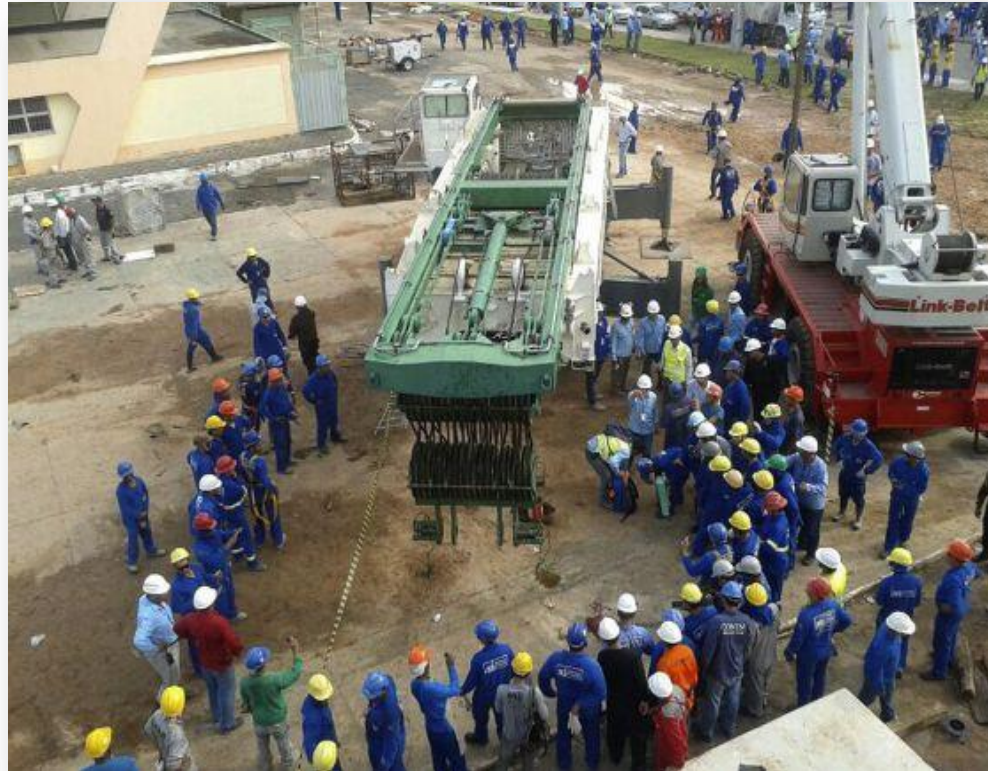
Amazonia Stadium (Manaus).

A 55-year-old Portuguese man became the third worker to die at this venue in less than a year after being struck on the head by a component while disassembling a crane used to install the stadium's roof.

- We must insure that all work equipment has been subject to a regular compliance inspection regime and is fit for purpose.
- During the disassembly of large equipment/ plant clearly demarcated exclusion areas shall be strictly adhered too at all times.

- The majority of the accidents took place in the final hours of the working shift. Investigation into the accident involving the crane dismantle at Itaquerao revealed the operative had already worked a 14 hour shift.

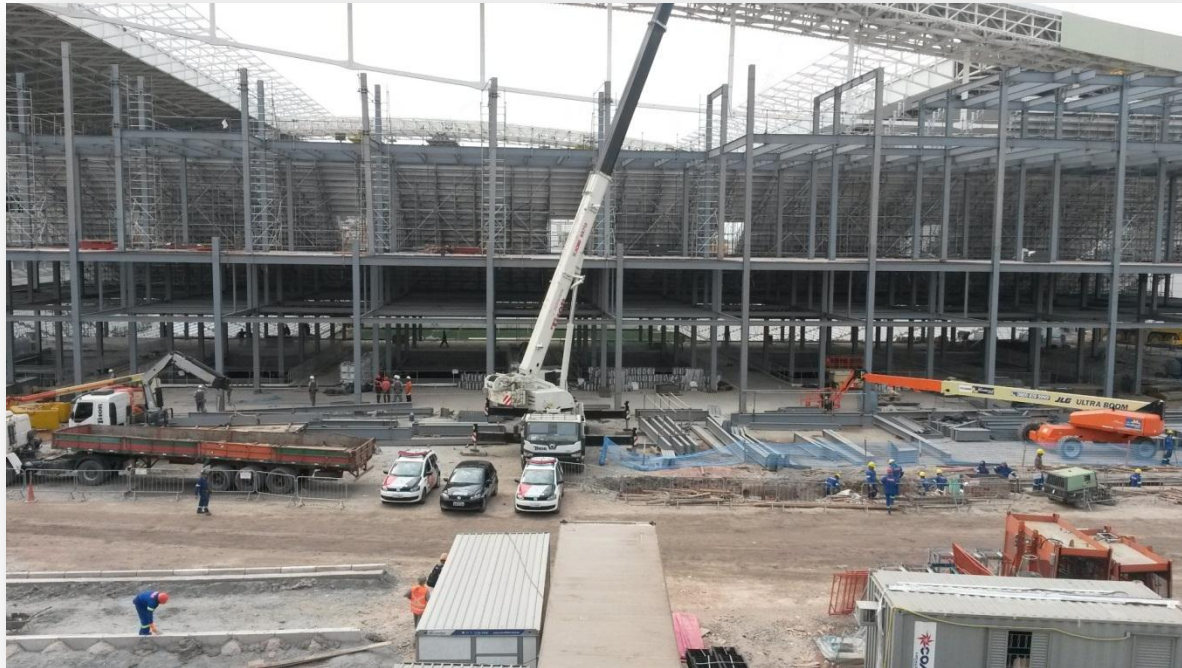
Itaquerac Stadium (Sao Paulo)

Fabio Hamilton da Cruz , a 23 year-old construction worker died after falling approximately 26 feet whilst installing temporary seats.

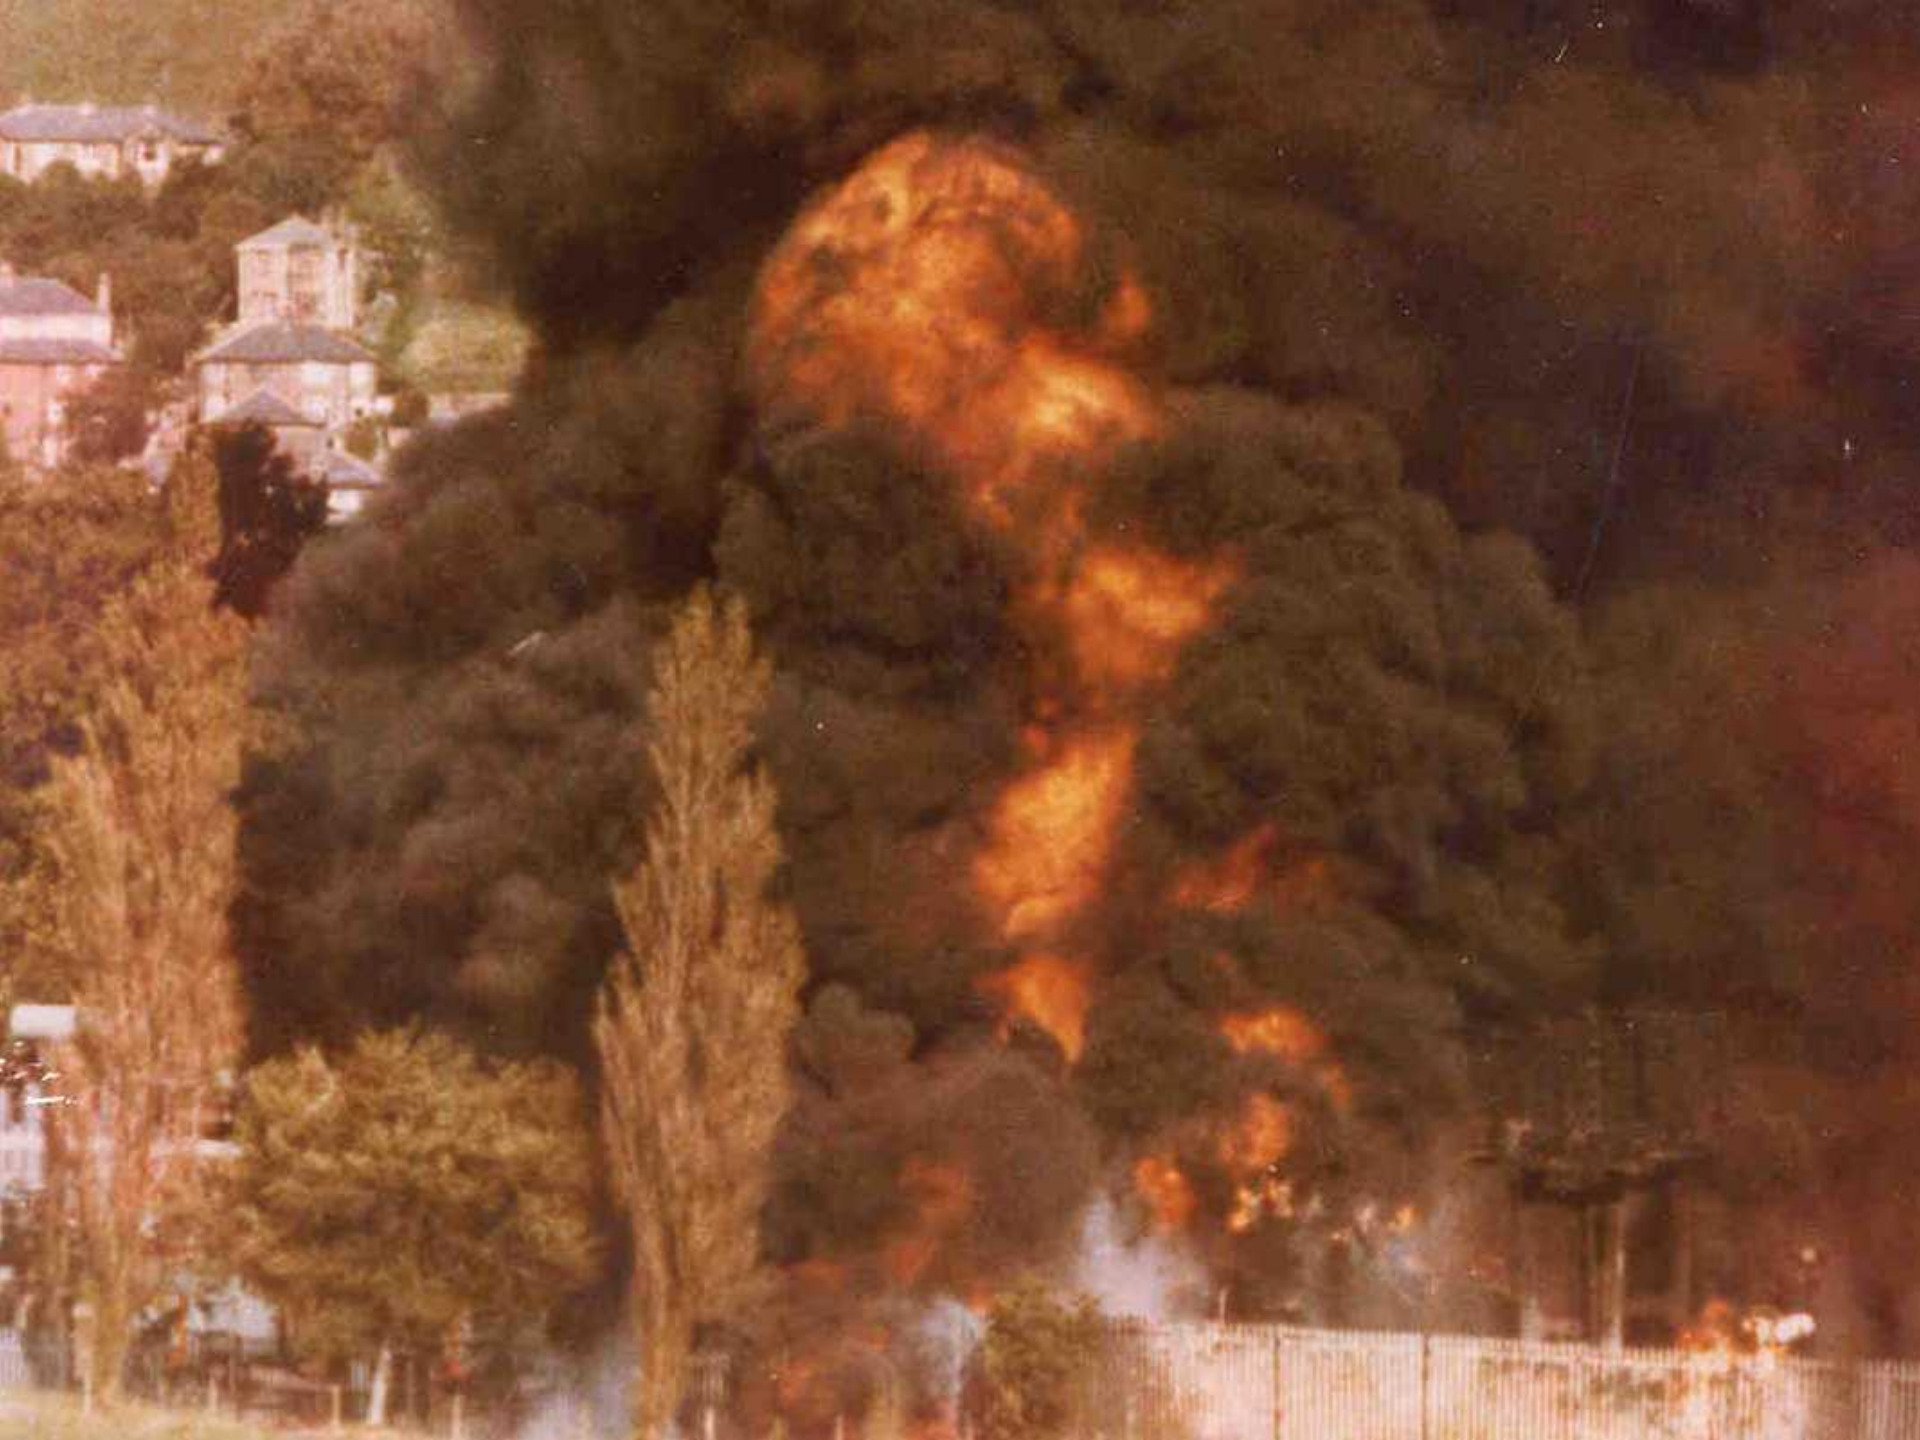
HV Test Probe Incident

- Two engineers killed as a result of an explosion in an oil-filled RMU.
- Metal locating pin fell into oil tank due to loose nut.
- 180 MVA fault level.
- Test probes now modified.
- Safe storage of probes implemented.
