The Importance of Accurate Data in Outage Investigations Carried out by Wellington Electricity to Improve the Management of its Assets

Rebecca Harkerss – Graduate Engineer

18th August 2017

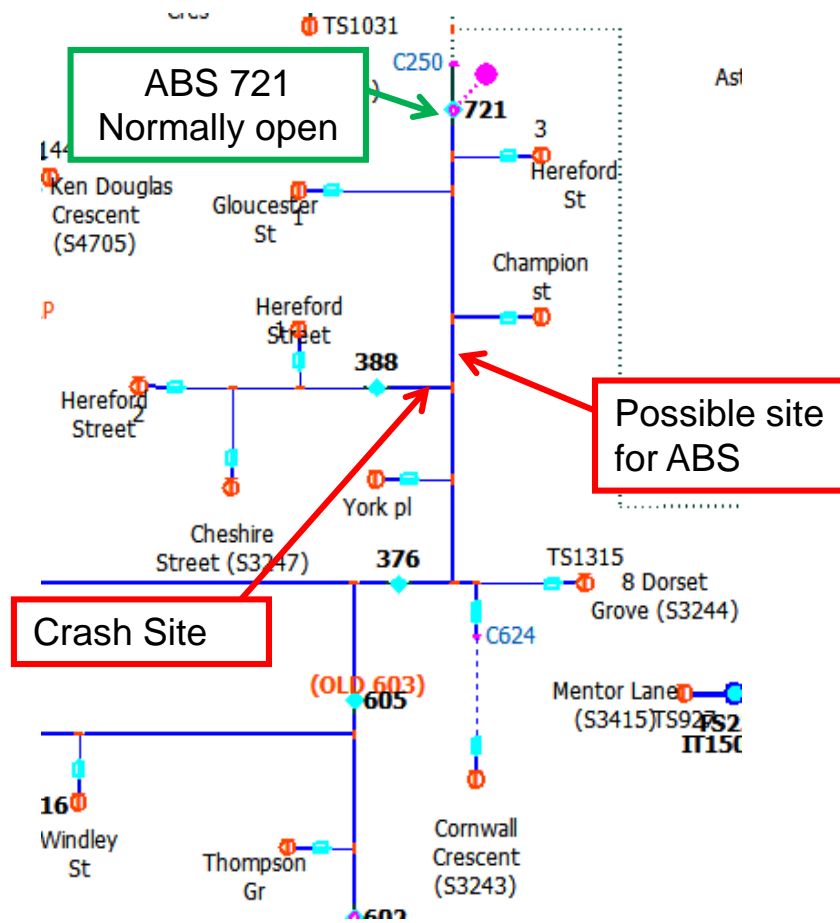
- **Date and Time:** 30/05/2017 9:30 a.m.
- **Feeder:** Porirua CB9
- **# Customers affected:** 1308
- **Cause:** 2 Cars vs Poles

Recommendations:

- Investigate installing an air break switch (ABS) between the Hereford Street 'T-off' and the Champion Street substation.
- Redo LV link at Gloucester Street No 1 sub.

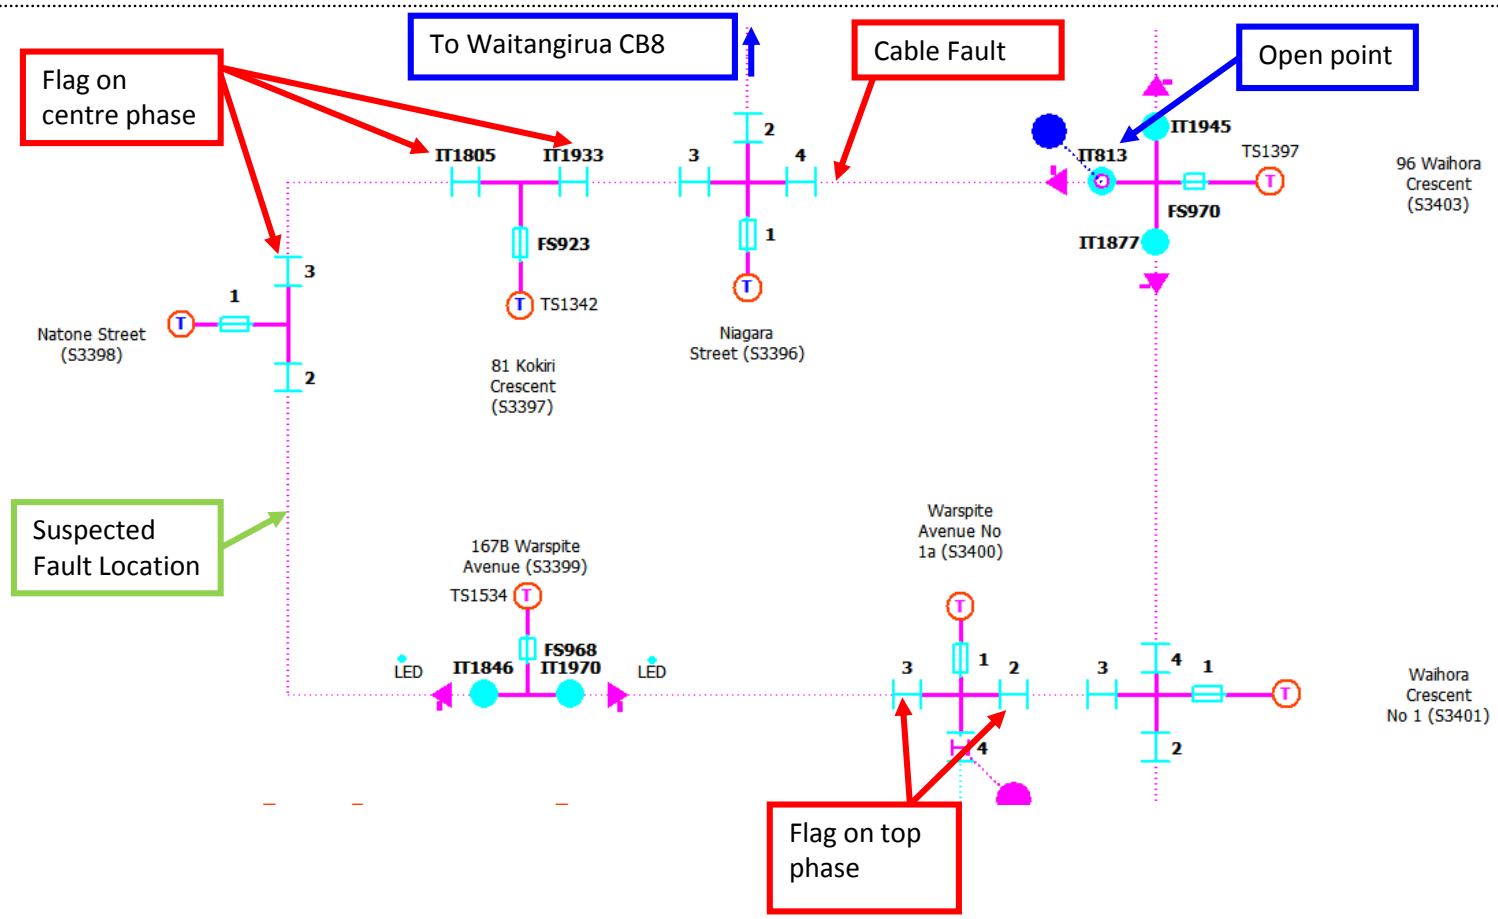
Example #2 – Waitangirua CB8 – 19th May 2017

- **Date and Time:** 19/05/2017 2:17 a.m.
- **Feeder:** Waitangirua CB8
- **# Customers affected:** 724
- **Cause:** Cable Fault

Recommendations:

- Northpower will check Magnefix unit flags and reset them (where necessary) during the next annual inspection.
- Update standard for annual inspection to include checking and resetting flags.
