Condition Assessment Criteria

And the Data Required for Hydropower Generating
Units

APEX 2017

Jarrold Wyatt

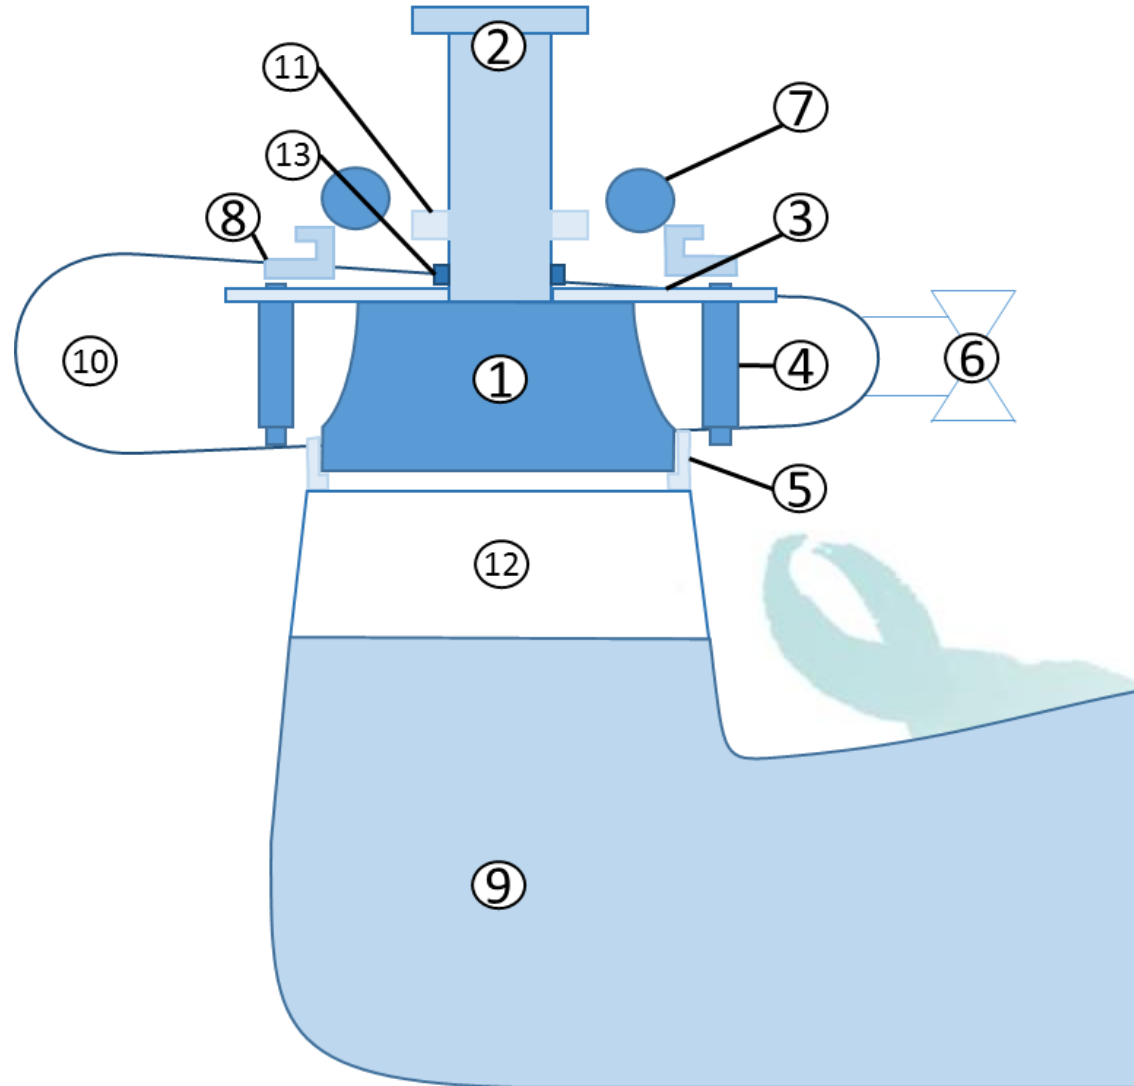
Hydroturbine

Item	Component
1	Runner
2	Shaft and Coupling
3	Head Cover
4	Wicket Gates
5	Discharge Ring
6	Bypass Valve
7	Servomotors
8	Wicket Gate Actuation Assembly
9	Draft Tube Concrete
10	Scroll Case
11	Turbine Bearing
12	Draft Tube liner
13	Shaft Seal

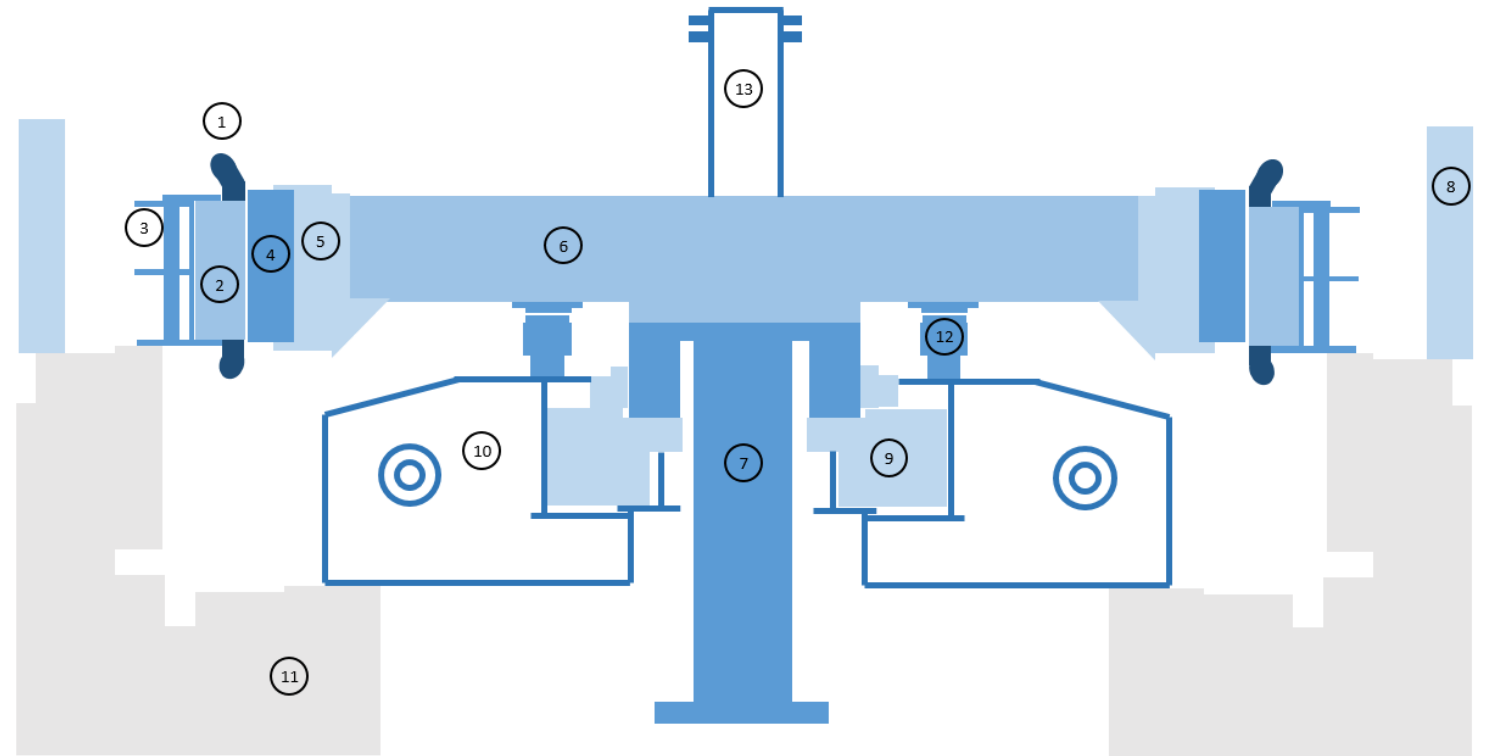
Hydrogenerator

Item	Component
1	Stator Winding
2	Stator Core
3	Stator Frame
4	Rotor Poles
5	Rotor Rim
6	Rotor Spider/Hub
7	Generator Shaft
8	Stator Coolers
9	Combined Bearing
10	Thrust Bracket
11	Foundations
12	Brakes and brake track
13	Excitation shaft
